DEPARTMENT OF TRANSPORTATION**DIVISION OF ENGINEERING SERVICES**

Quality Assurance and Source Inspection

Contract #: 04-0120F4Cty: SF/ALA Rte: 80 PM: 13.2/13.9File #: 1.28**WELDING INSPECTION REPORT****Resident Engineer:**Pursell, Gary**Address:** 333 Burma Road**City:** Oakland, CA 94607**Report No:** WIR-015031**Date Inspected:** 22-Jun-2010**Project Name:** SAS Superstructure**OSM Arrival Time:** 1100**Prime Contractor:** American Bridge/Fluor Enterprises, a JV**OSM Departure Time:** 1930**Contractor:** American Bridge/Fluor Enterprises, a JV**Location:** Job Site**CWI Name:** See Below**CWI Present:** Yes No**Inspected CWI report:** Yes No N/A**Rod Oven in Use:** Yes No N/A**Electrode to specification:** Yes No N/A**Weld Procedures Followed:** Yes No N/A**Qualified Welders:** Yes No N/A**Verified Joint Fit-up:** Yes No N/A**Approved Drawings:** Yes No N/A**Approved WPS:** Yes No N/A**Delayed / Cancelled:** Yes No N/A**Bridge No:** 34-0006**Component:** Orthotropic Box Girders**Summary of Items Observed:**

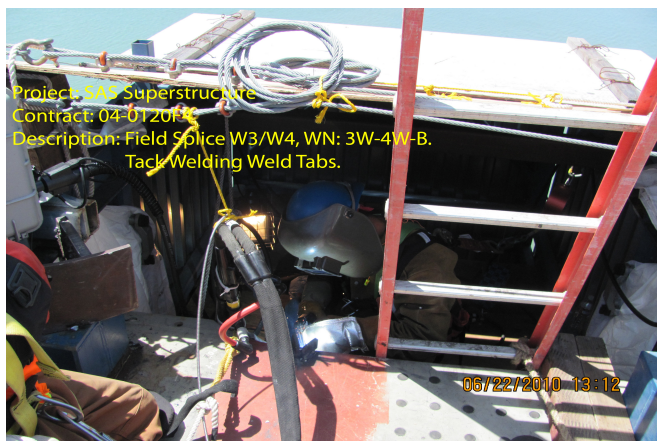
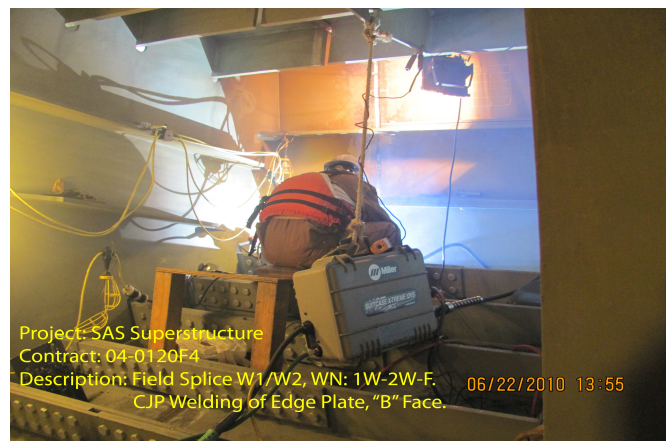
The digital photographs below illustrate the work observed during this scheduled shift.
